# Manhole Inspection Summary

Manhole # S29EE2002MH

**Location** Address: **5615 BOXHILL LN**

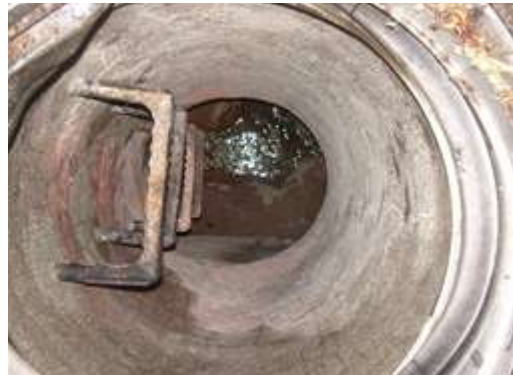
Top View

Adjustment, Corbel and Barrel infiltration.  
Bench debris.

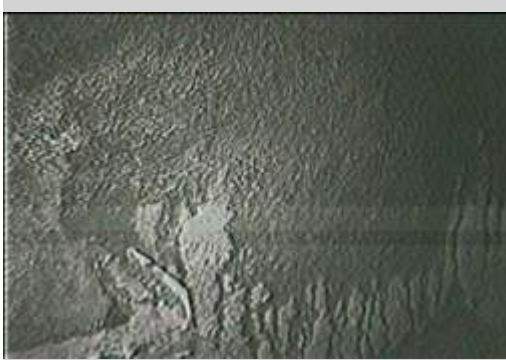
Defect

Barrel infiltration.

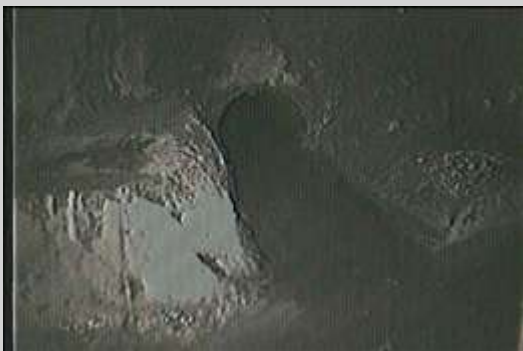
### 8 in. Circular Gravity Sewer Pipe In @ 2 O'Clock

Infiltration: **Evidence** Pipe Seal Cond: **Unknown**

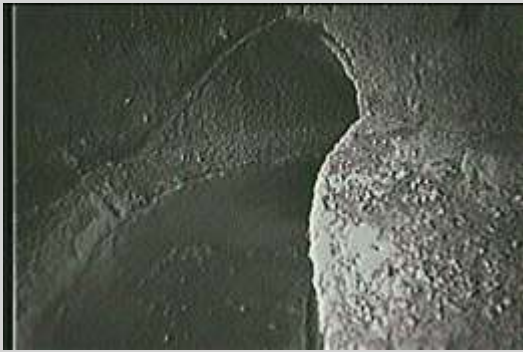
### 15 in. Circular Gravity Sewer

Infiltration: **Evidence** Pipe Seal Cond: **Unknown**

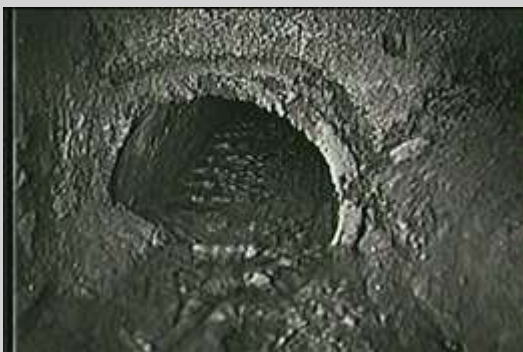
### 8 in. Circular Gravity Sewer

Infiltration: **Evidence** Pipe Seal Cond: **Unknown**
